**WDID:** 6B361105001

**Re: Supplementary Report to Notice of Violation - Deficient Report Complaint To A Notice of Violation Regarding An Unauthorized Discharge, Hometown America's Los Ranchos Mobile Home Park, Town of Apple Valley, San Bernardino County**

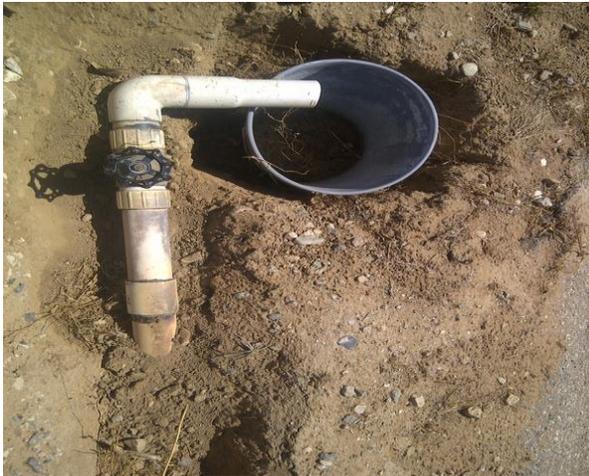
Item No. 1 – As indicated in HA's September 2, 2011 NOV response letter, the drain pipe noted is believed to be part of the original plant design, possibly an old leach line, but its purpose is not known. The operator reported that minor amounts of potential discharge from the referenced drain pipe was contained by placing a bucket beneath the outlet to capture any discharge from the pipe, as seen in photo below. The discharge dripped into the bucket and was inspected daily by

the operator and drained periodically into the plant headworks. The dripping stopped after a few weeks. According to the Plant operator, the only discharge ever noticed was a periodic drip into the bucket, typically less than 1 gallon per week during the rainy season, the amount captured was estimated at less than 8 gallons. There has been no discharge whatsoever for several months and the end of the drain pipe has been permanently capped off, as seen in the photo below.

drain pipe emptying into bucket

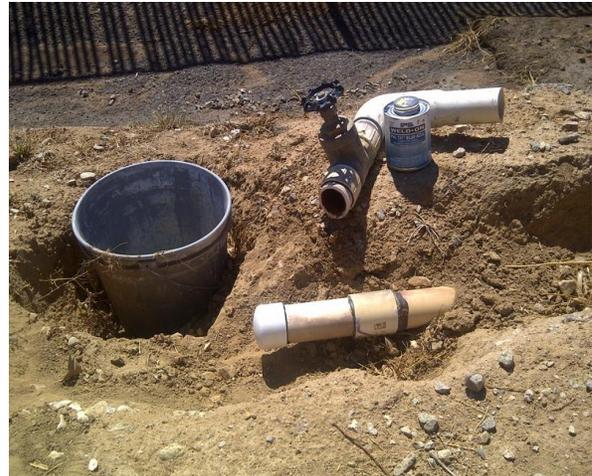
capped drain pipe

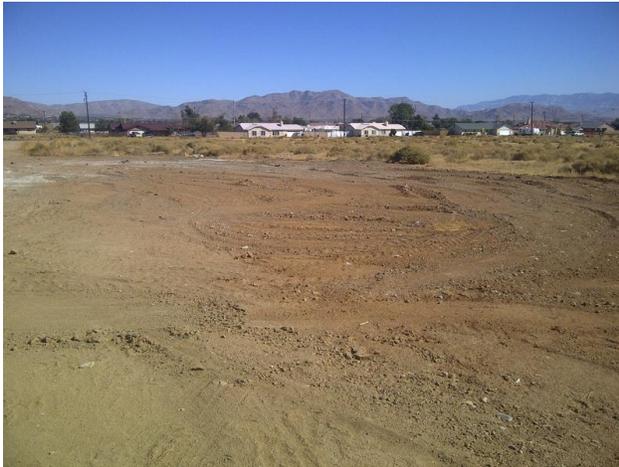
Item No. 2 – Pictures of the area where the dry material from the large percolation pond cleaning was temporarily stored are included, showing that the area has been thoroughly cleaned. The pond was thoroughly dried prior to cleaning. The material was primarily carbonate crust and soil. It is our understanding that no disinfection of the area was performed by the contractor due to the dry nature of the material.

south side of WWTP looking east

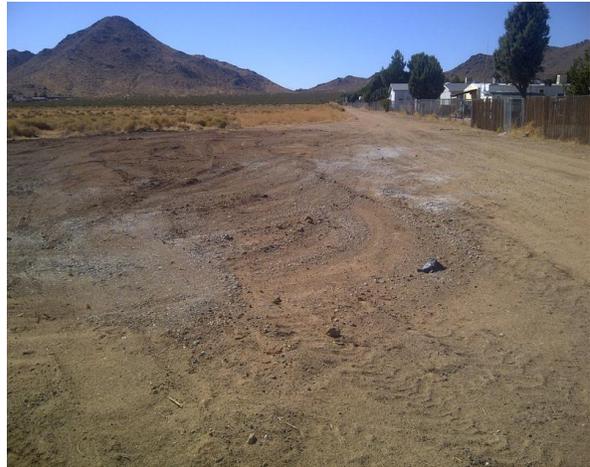
south side of WWTP looking west

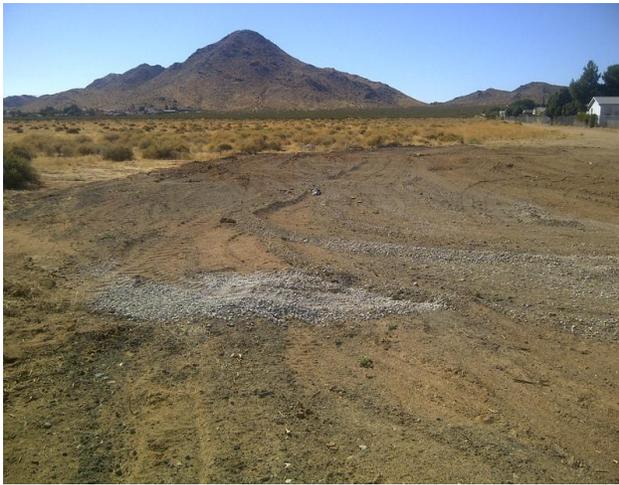
south side of WWTP looking east

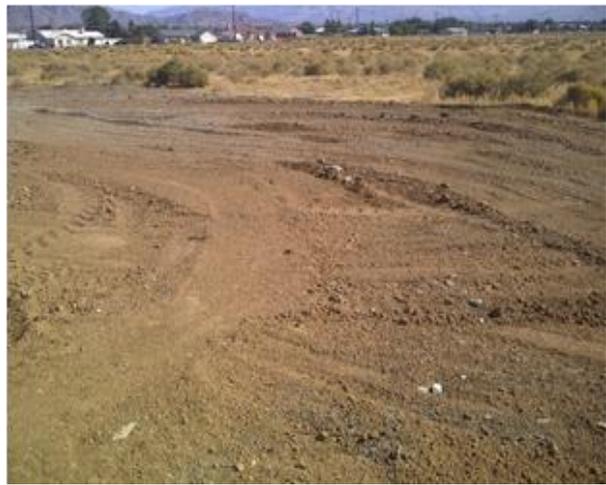
south side of WWTP looking west
